STRATHMEADE SQUARE

SECTION III

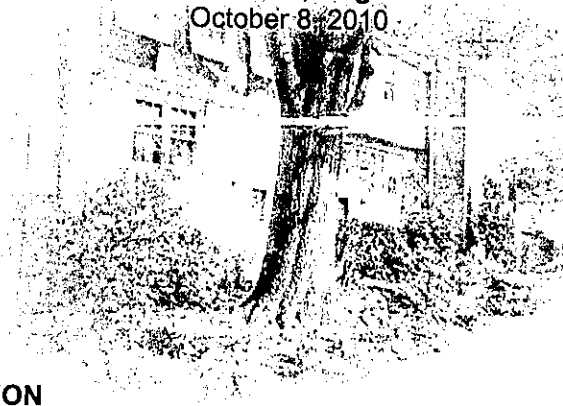
### A. GENERAL INFORMATION

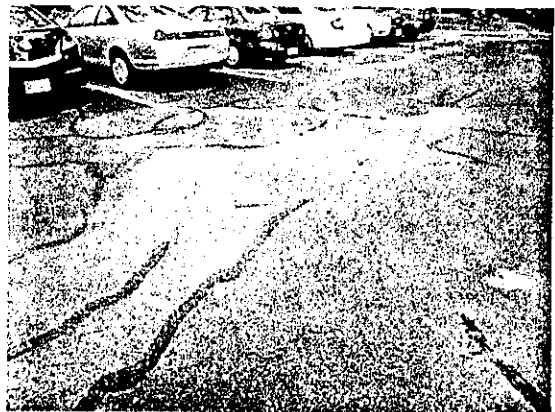
As noted above, the remaining 70 percent of the asphalt pavement is generally in good condition considering the age of the pavement and we have scheduled this pavement for replacement in 2018. This project is identified as "Phase Two" or "P2" in the Replacement Reserve Inventory.

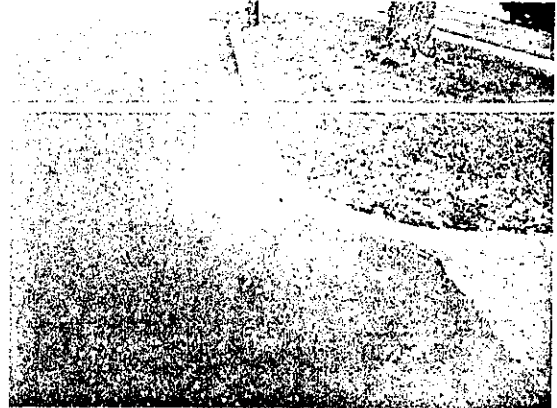
The project to replace the asphalt pavement should include the evaluation of all damaged and deteriorated pavement. Areas of asphalt pavement with minor defects that are limited to the asphalt pavement, where the base materials and bearing soils have not been damaged, may be repairable with one of the fabric reinforcing sheets in use today, to prevent defects from printing through to the new asphalt pavement.

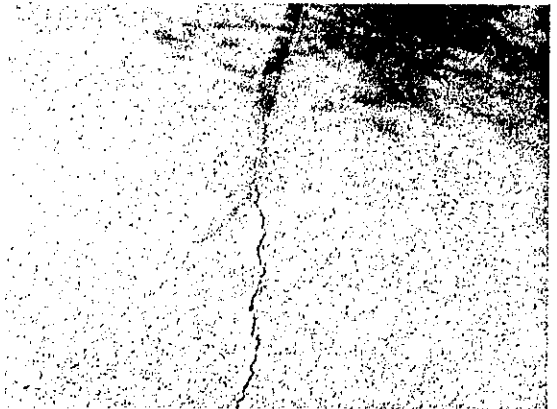
In multiple locations the concrete curb & gutter segments are damaged and/or displaced. These defective segments of curb & gutter will prevent proper grading of the new asphalt pavement and/or allow water to penetrate into the bearing soils beneath the curb & gutter segments and adjacent asphalt pavement. These curb & gutter segments should be replaced before, or in conjunction with,

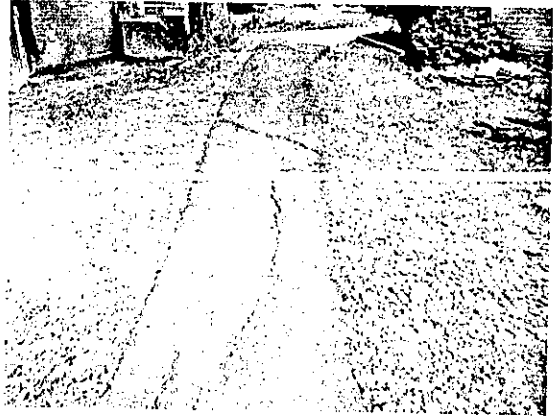
**Asphalt Pavement Maintenance Program.** If the Phase One and Phase Two asphalt pavement is to be kept in service until 2013 and 2018 respectively, the Association will need to establish an aggressive Asphalt Pavement Maintenance Program. This program should include the components discussed below:

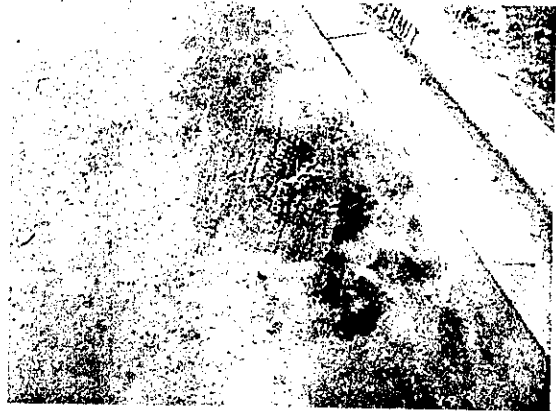
# REPLACEMENT RESERVE REPORT

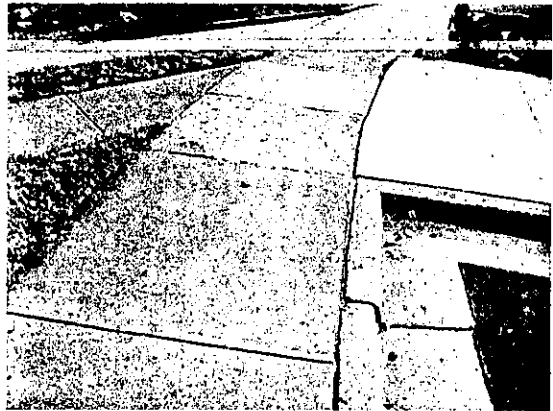
In the Replacement Reserve Inventory, we have assumed that 5 percent of the adjacent concrete components will be replaced in conjunction with the Phase One and Phase 2 Asphalt Pavement Replacement Project scheduled in 2013 and 2018. Subsequent cycles of concrete component replacements are scheduled at 16 year intervals in the *Replacement Reserve Inventory*, to coincide with future asphalt replacement projects. We have accelerated the percentages of concrete components scheduled for replacement in future projects to reflect a normal aging pattern. Interim replacements may be necessary and in the *Replacement Reserve Inventory*, we have assumed that these replacements will not be funded from Replacement Reserves.

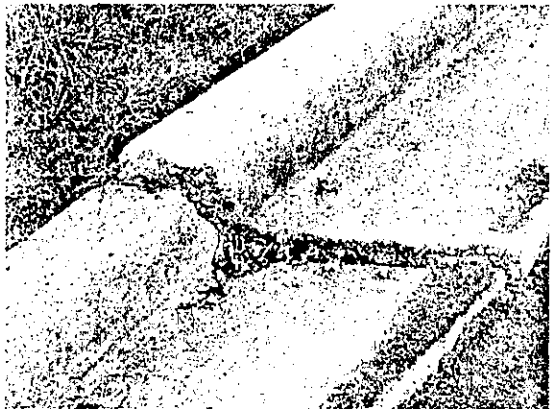
# REPLACEMENT RESERVE REPORT

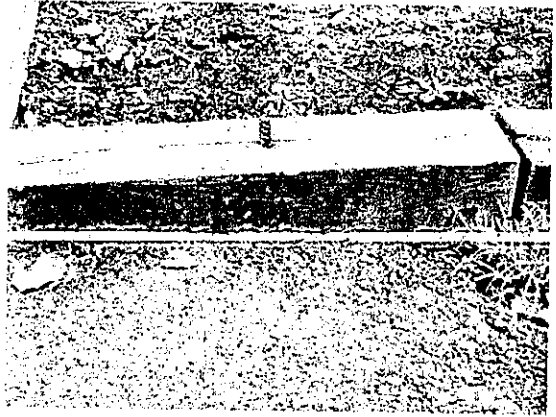
**Community Building.** A concrete walkway is cantilevered from the building structure on all 4 sides of the upper level of the Community Building. The absence of a waterproof traffic coating on the exposed structural concrete is allowing water penetration and if not stopped, it will result in damage to the steel reinforcing and will require a expensive restoration project. We have included the installation of a protective waterproofing membrane in the List of Recommended Repairs.

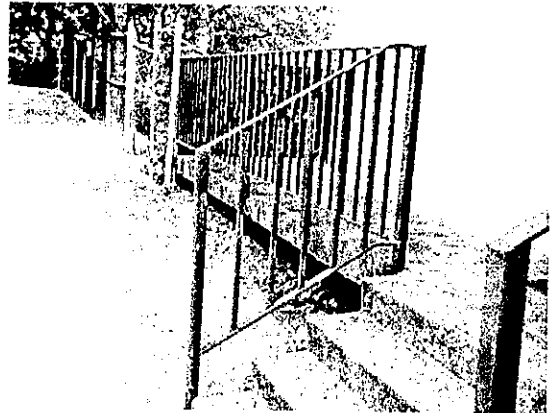
The project should include the restoration of the metal railing and the metal railing attachment points.

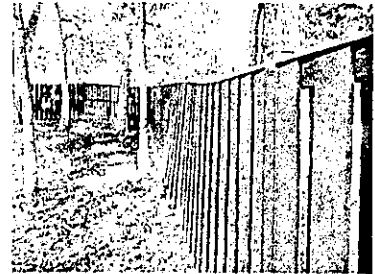
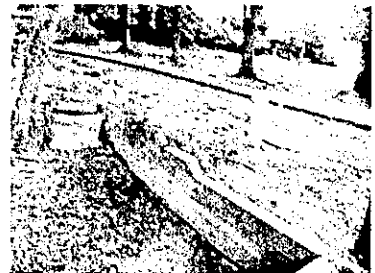
The percentage of the components scheduled for replacement should be adjusted in future years based on historical data and experience. All other components are included in the *Replacement Reserve Inventory* at their full estimated replacement cost.

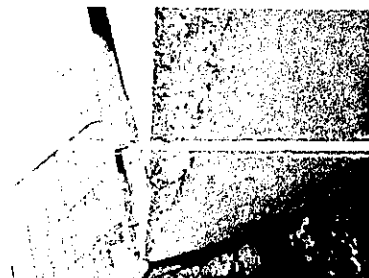
**Value.** For ease of administration of the Replacement Reserves and to reflect accurately how Replacement Reserves are administered, components with a dollar value less than \$2,000.00 have been excluded from the *Replacement Reserve Inventory*. Examples of components excluded from the *Replacement Reserve Inventory* by this standard include:

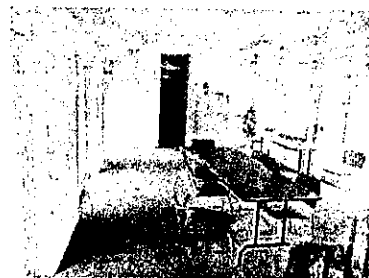
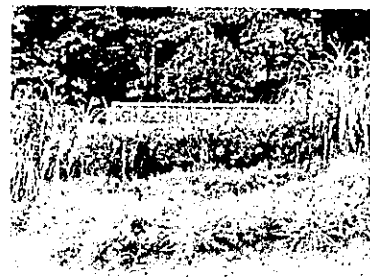
**Unit improvements.** We understand that the elements of the project that relate to a single unit are the responsibility of that unit owner. Examples of components excluded from the *Replacement Reserve Inventory* by this standard include:

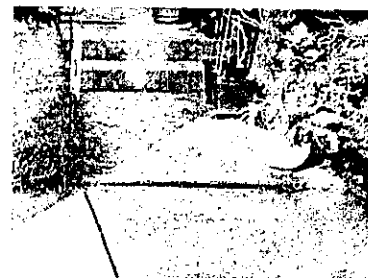
# REPLACEMENT RESERVE REPORT

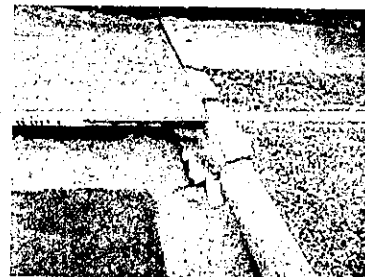
**Domestic water supply mains.** There is an extensive network of domestic water mains installed throughout the community on property owned by the Association. No drawings detailing the components of the system were available for our review. For the purpose of the *Replacement Reserve Inventory*, we have excluded this system and assumed that any needed replacements will not be funded from Replacement Reserves.

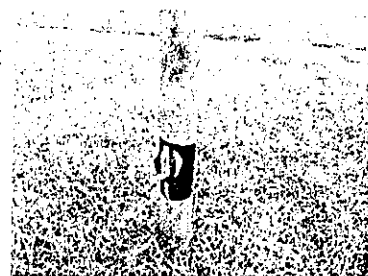
**Maintenance Activities.** Maintenance activities are NOT appropriately funded from Replacement Reserves. Funding maintenance and repair activities from Reserves may have adverse tax consequences for the Association. Examples of components excluded from the *Replacement Reserve Inventory* by this standard include:

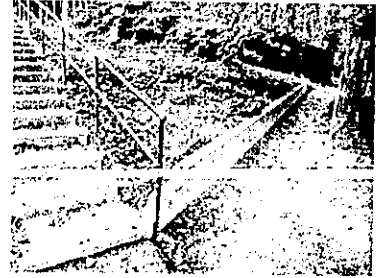
**Government.** Site improvements that serve the community are located on property owned by the local or state government. These improvements are located in the following areas:

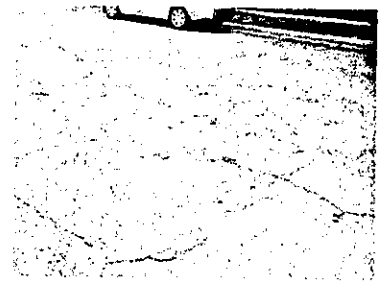
We have assumed that any needed repairs or replacements of components located in these areas are not the responsibility of the Association and costs associated with any work on these components will not be funded from Replacement Reserves.. They component located in these areas include but are not limited to those listed.

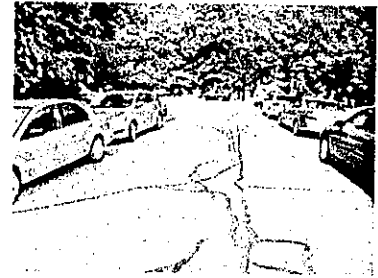
- Asphalt pavement.
- Concrete curb & gutter.
- Storm water management system components.
- Utilities, including electrical, sanitary sewers, domestic water mains, and natural gas.

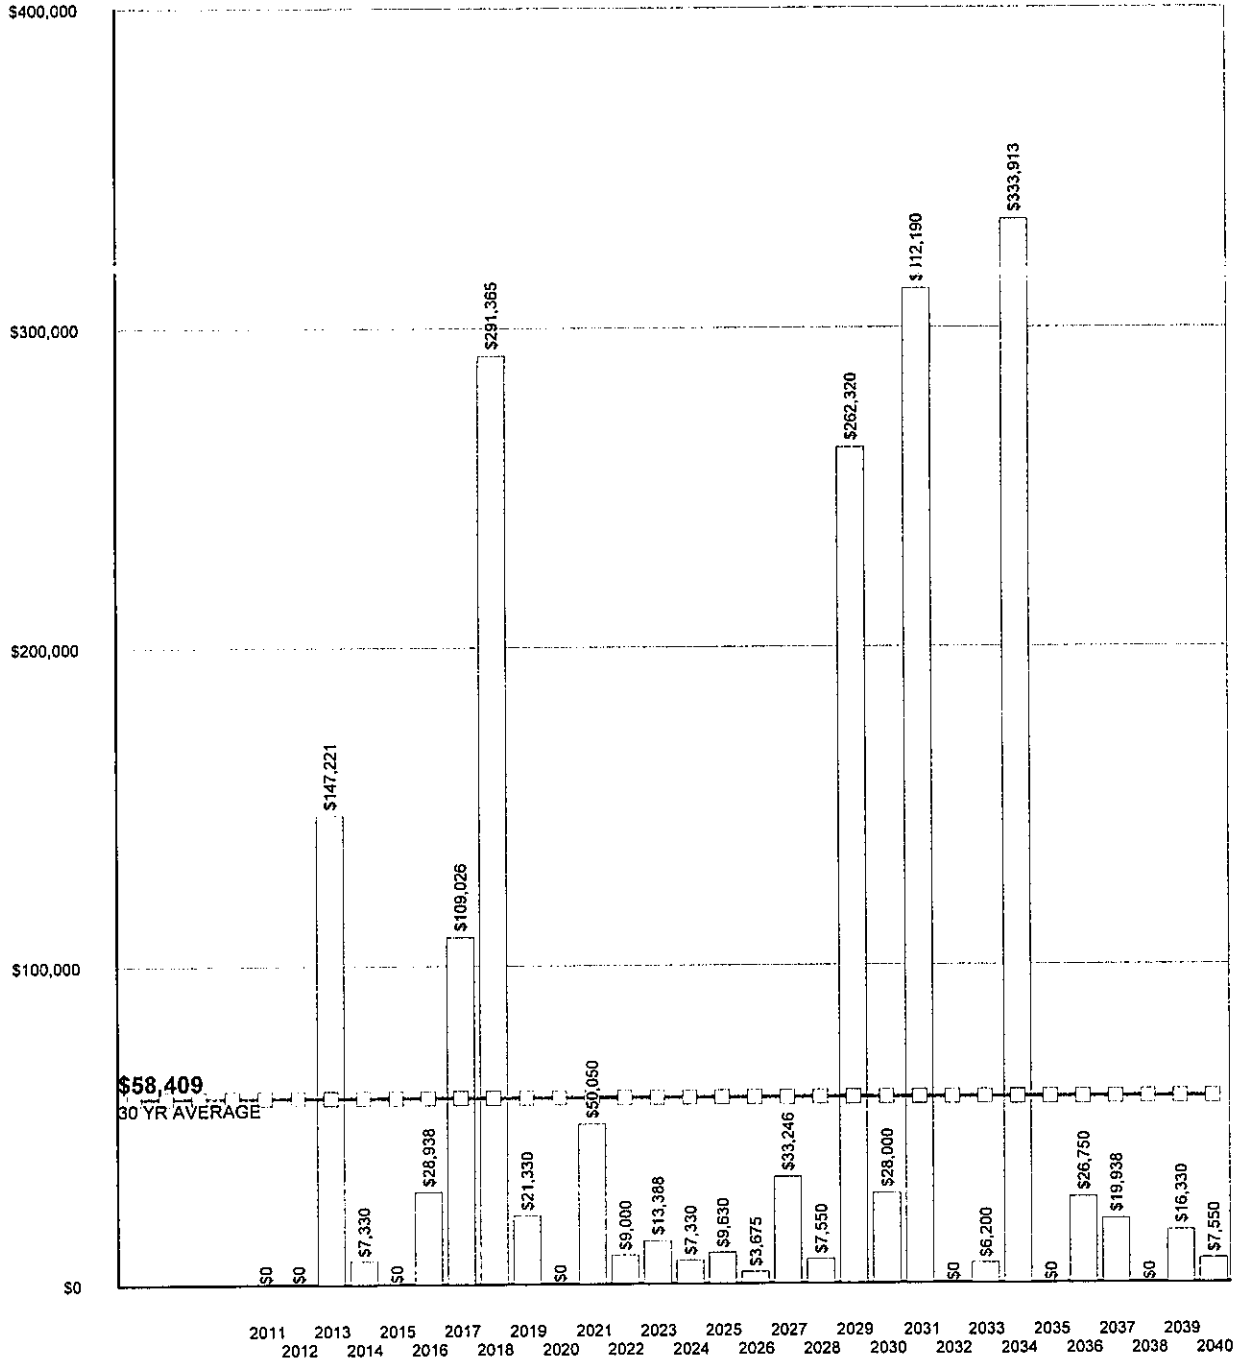
**Richard J. Schuetz, AIA, Architect**

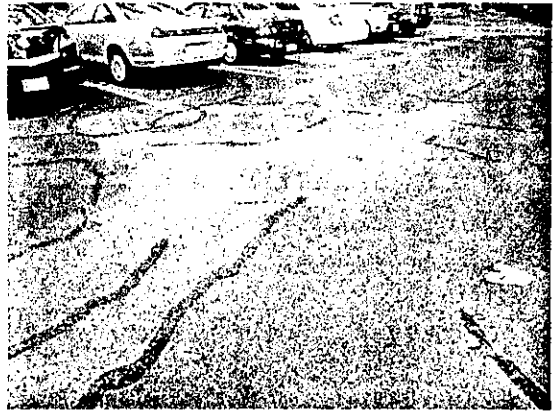
- Clean all asphalt pavement. Clean areas that have been damaged by oil/gasoline and if cleaning is ineffective, the damaged areas should be cut out and replaced.

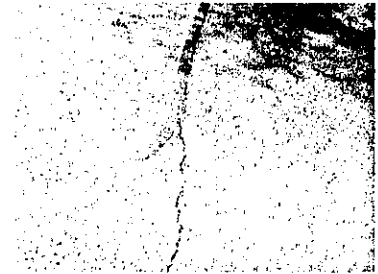
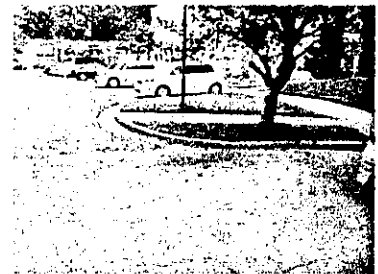
# LIST OF RECOMMENDED REPAIRS

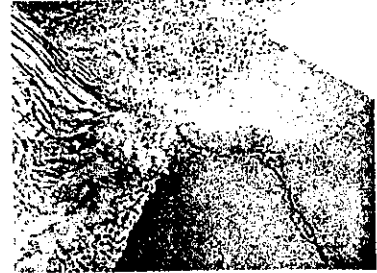
- **Extend the system of asphalt trails to connect with the sidewalks along Tobin Road.** See Supplemental Photographs #63, 117.

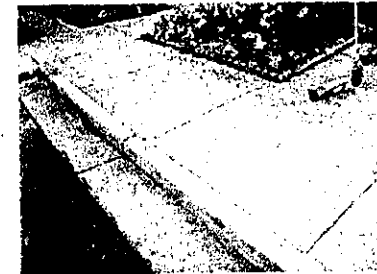
- **Displaced segments of concrete pavement (with a difference in elevation over 1 inch) which are trip hazards.**
- **Spalling segments of concrete pavement.** Segments with loose or very rough pavement are trip hazards.

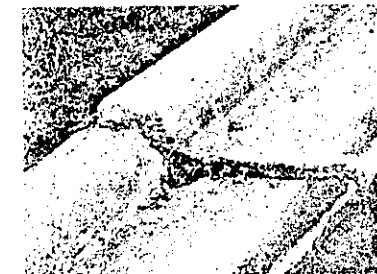
- **Defects that are typical of concrete pavement and listed under concrete pavement above.**
- Segments with defects that allow water to penetrate into the base materials and bearing soils beneath the curb & gutter and adjacent asphalt pavement.
- Segments that prevent the proper grading of asphalt pavement repairs.

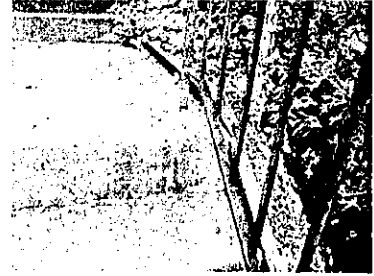
- Defects that are typical of concrete pavement and listed under concrete pavement above.
- Steps with uneven risers or risers greater than 8.25 inches.

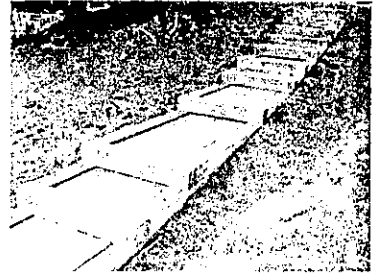
### 3. Grading, drainage, and landscape.

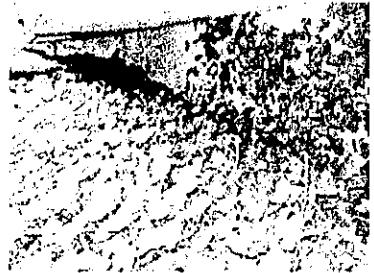
- Evaluate the sunken area near the Whipple Tot Lot and correct the defect causing the damage. See Supplemental Photographs #47.

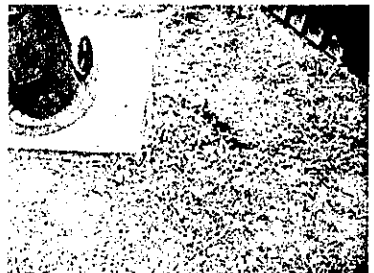
## LIST OF RECOMMENDED REPAIRS

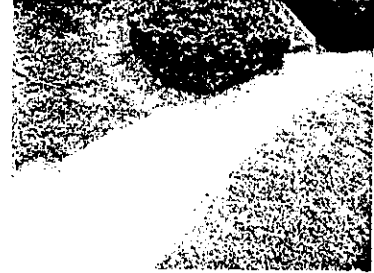
- Establish proper ground cover on property owned by the Association. Correct damage caused by erosion. See Supplemental Photographs #25, 38, 64, 95, 96, 117.

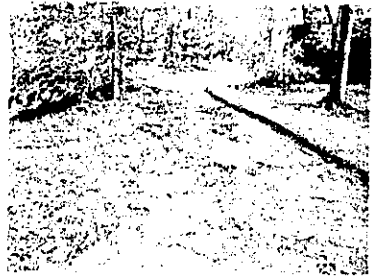
#### 4. Metal railings

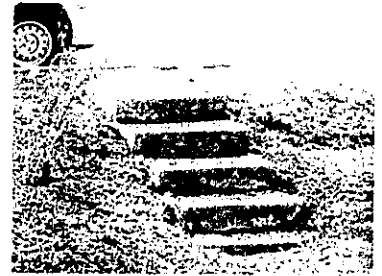
- Restore and paint all damaged and/or deteriorated exterior metal railings. See Supplemental Photographs #8, 48, 61.
- Fill all rail attachment sockets with an epoxy grout, mounded to prevent water being impounded against the metal railing. If the concrete stair is too structurally damaged to properly support the railing attachment, the stair should be replaced. See Supplemental Photographs #8, 22, 52.

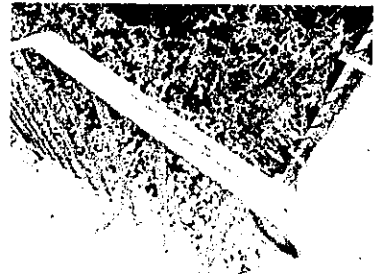
- Properly abandon unused railing attachment sockets. See Supplemental Photographs #9.

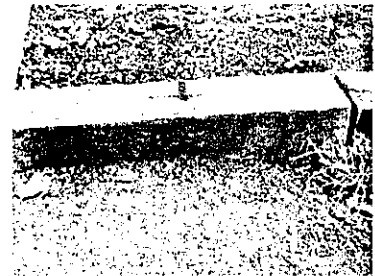
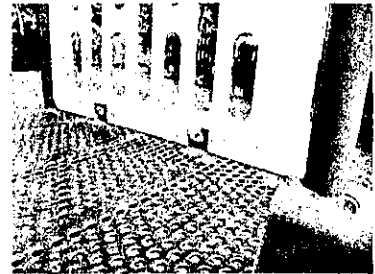
## 6. Site Improvements - Miscellaneous

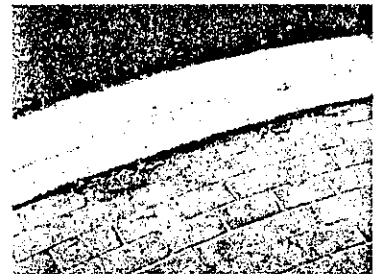
# LIST OF RECOMMENDED REPAIRS

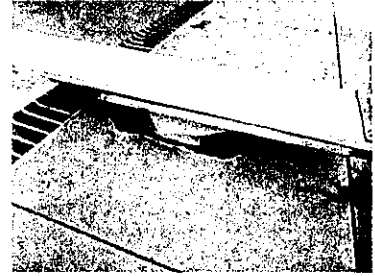
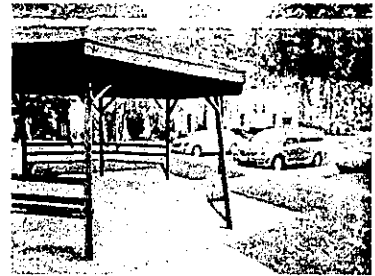
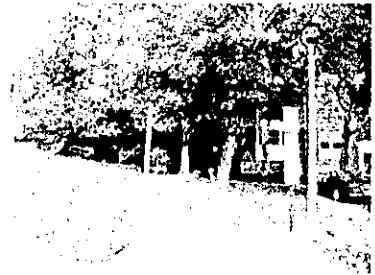
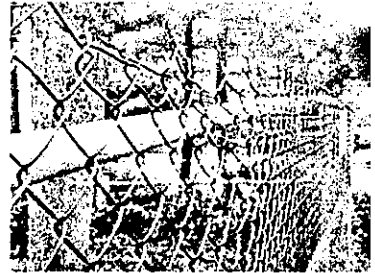
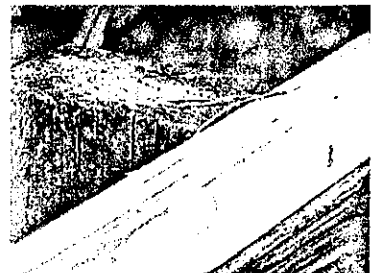
# LIST OF RECOMMENDED REPAIRS

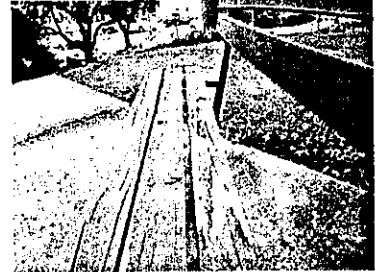
- Remove unnecessary pavers and wood curbs that are potential trip hazards that have been installed on property owned by the Association. See Supplemental Photographs #59.

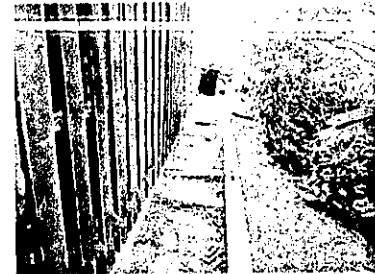
## 7. Community Building - Miscellaneous

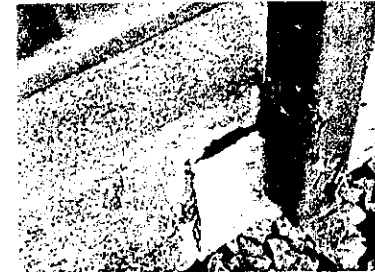
- Monitor the cracks in the foundation walls for additional movement. See Supplemental Photographs #12.

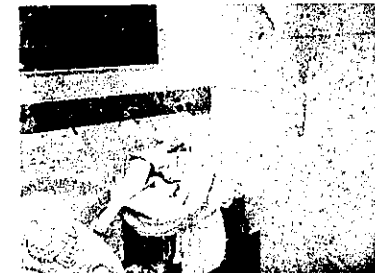
- Restore deteriorated finishes in the restrooms that serve the swimming pool. See Supplemental Photographs #13.

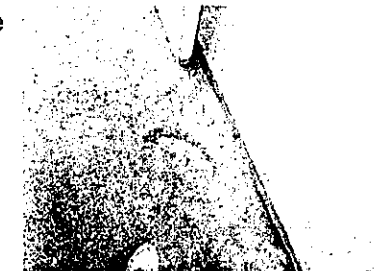
# LIST OF RECOMMENDED REPAIRS

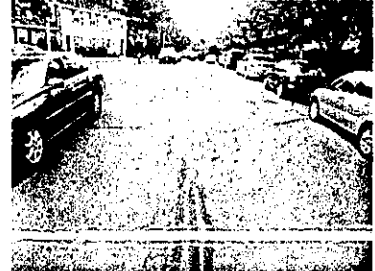
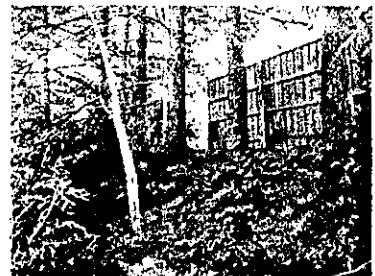
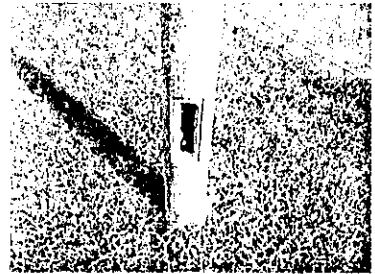
9. Replacement Reserves - The following projects listed in the Replacement Reserve Inventory and are scheduled for completion in the Study Year. Funding for these projects is assumed to be from Replacement Reserves and the costs are not included in the cost shown below for the defects cited in the Paragraphs above.

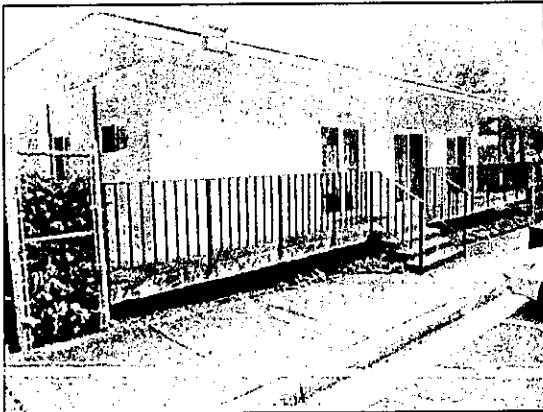
Photo #1. Photographs taken on August 21, 2010. General view of the Community Building.

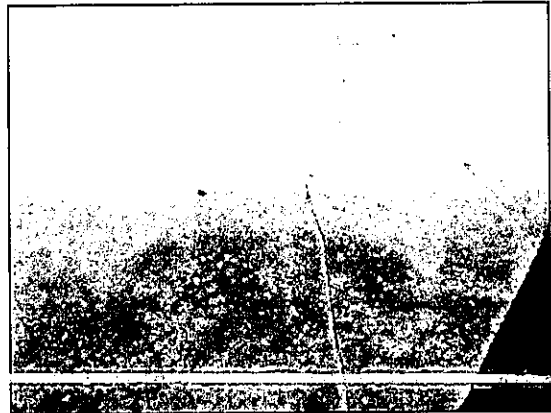
Photo #2. Upper surface of the concrete walkway that surrounds the upper level of the Community Building has defects that allow water penetration into the structure.

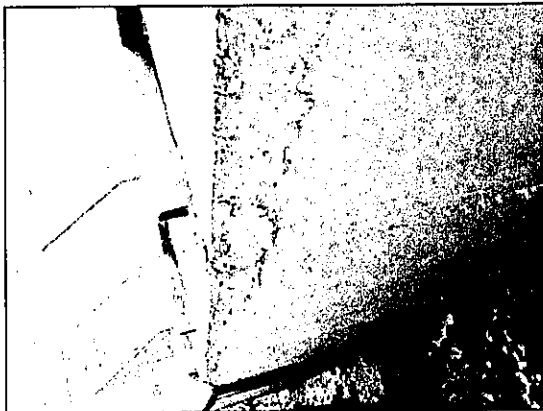
Photo #3. Evidence of water penetration through the concrete structure.

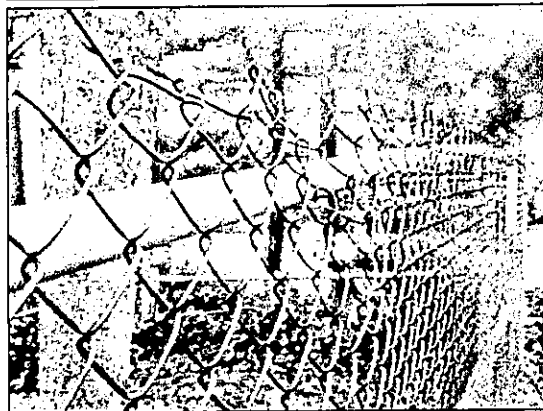
Photo #5. Minor damage to the fence surrounding the swimming pool.

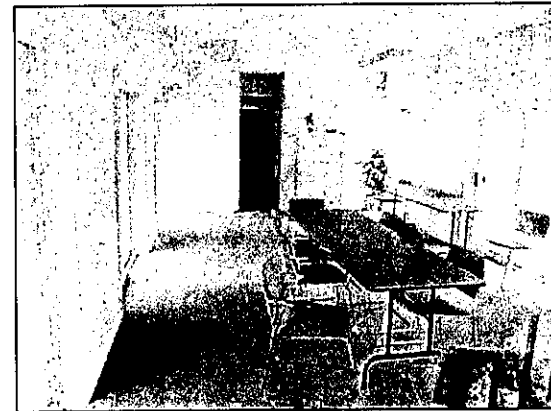
Photo #6. General view of the meeting room.

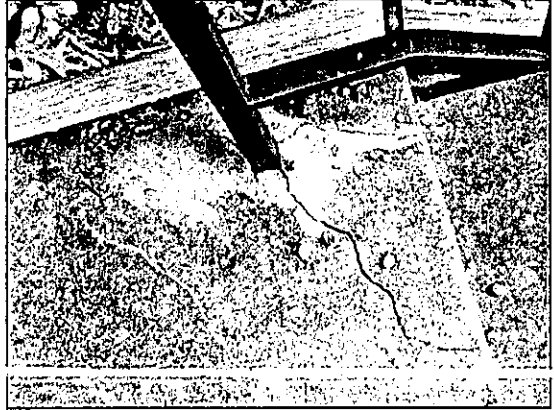
Photo #8. Failed stair railing socket. Note the failing paint finish on the metal railing.

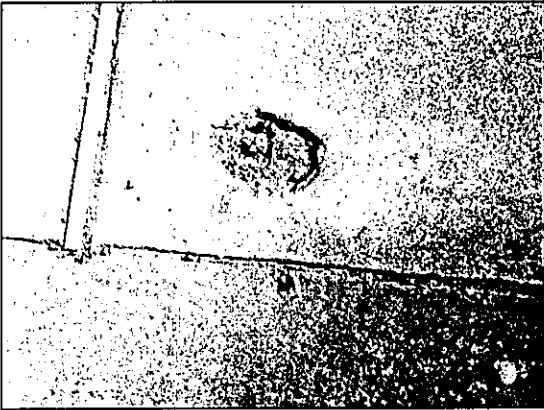
Photo #9. Defect in concrete pavement.

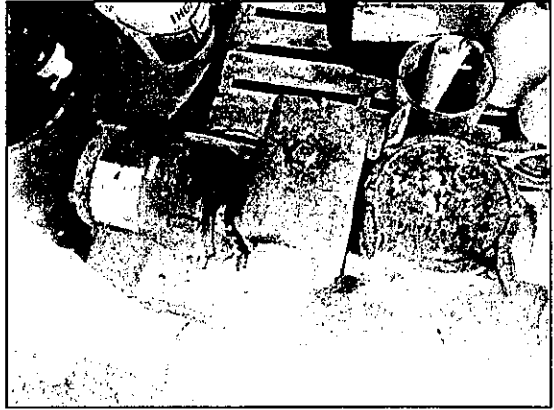
Photo #10. Pool Pump.

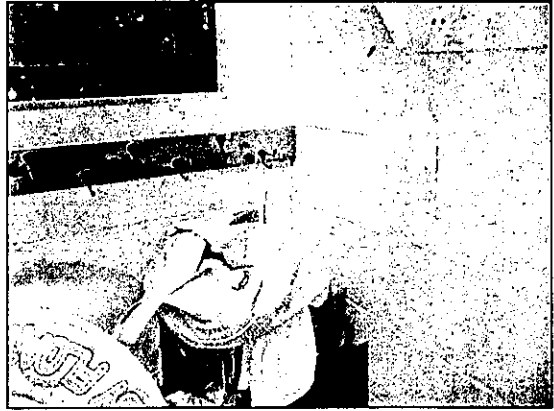
Photo #12. Open crack in the foundation wall.

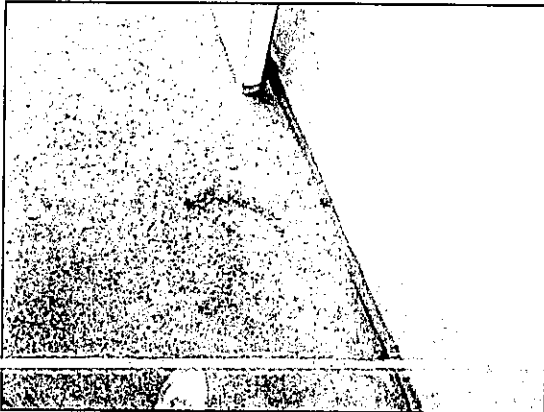
Photo #13. Floor finish.

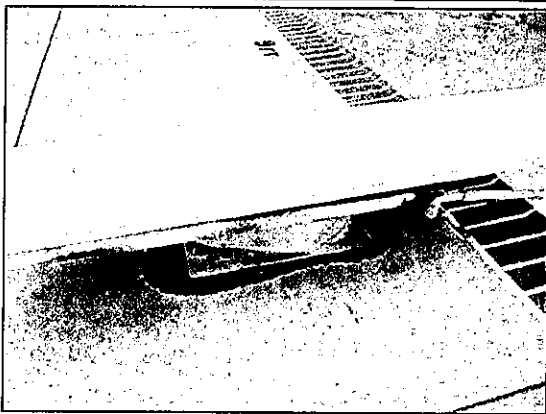
Photo #17. Diving board base and base attachment hardware is in rusting and deteriorated.

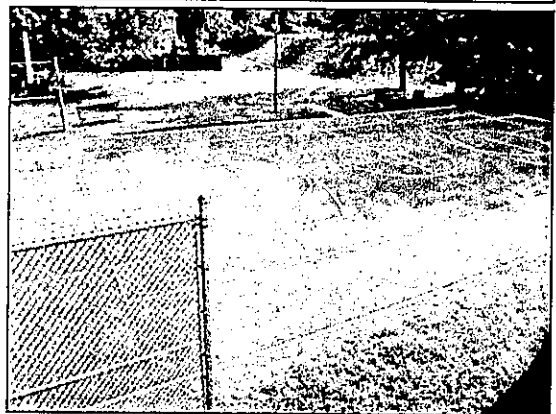
Photo #18. General view of the MP court adjacent to the swimming pool.

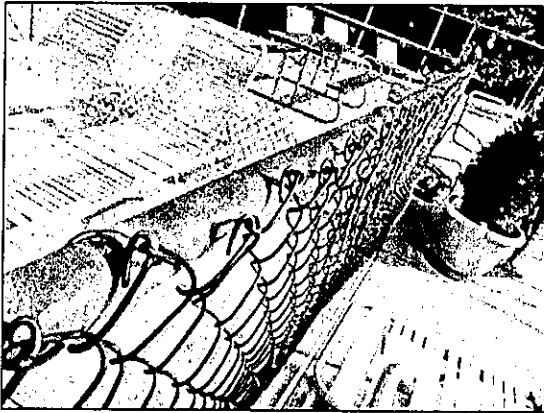
Photo #21. Top fence rail is rusting.

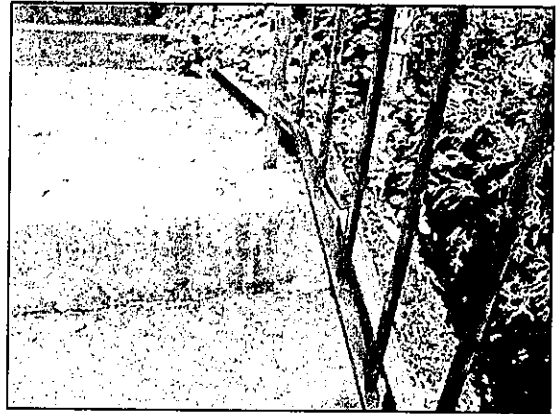
Photo #22. Concrete stair and railing is in poor condition.

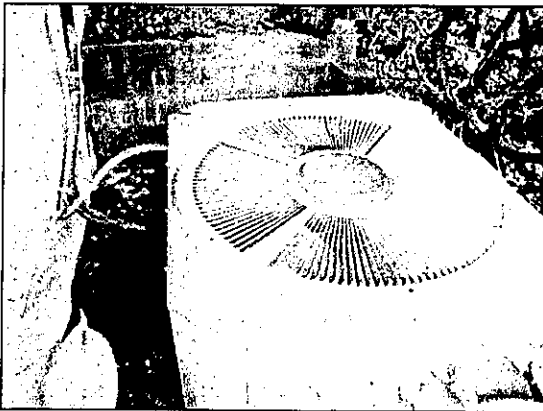
Photo #23. HVAC outdoor unit is installed in an area that may obstruct proper air flow.

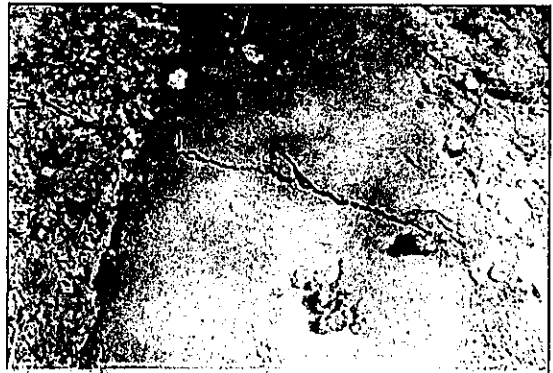
Photo #26. Typical large open crack in the asphalt trail.

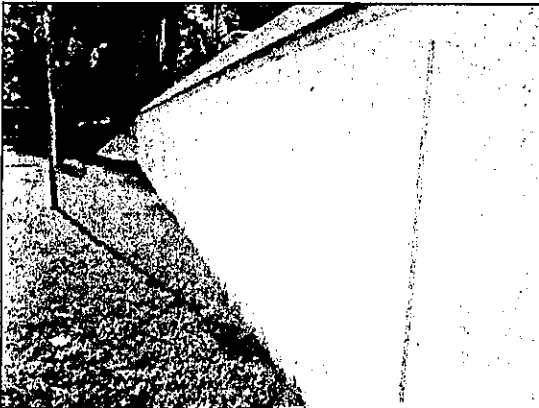
Photo #27. General view of the retaining wall that supports the swimming pools.

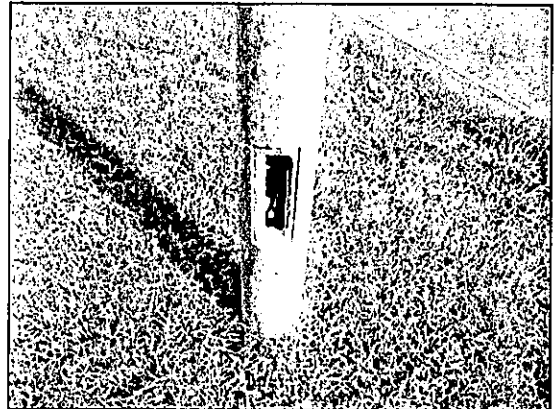
Photo #28. Open electrical junction box on the streetlight is a safety hazard.

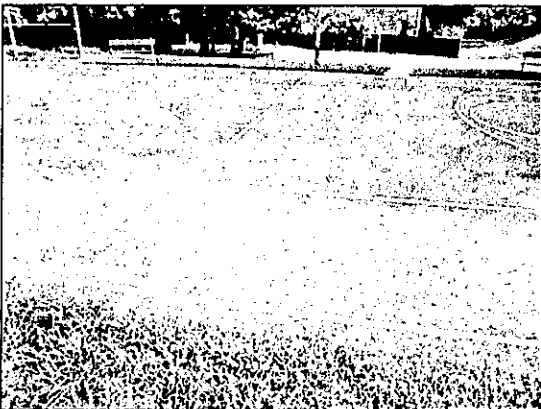
Photo #29. MP court surface exhibits some erosion but is generally in good condition.

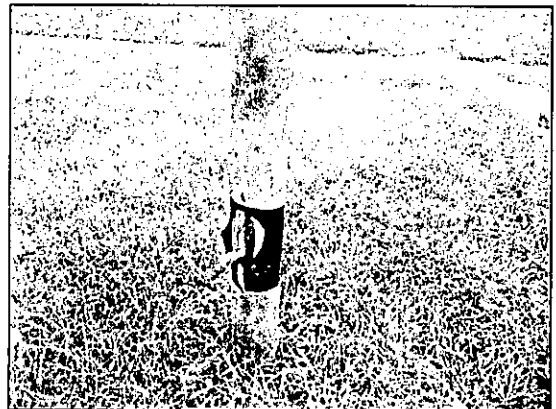
Photo #30. Open electrical junction box on the streetlight is a safety hazard.

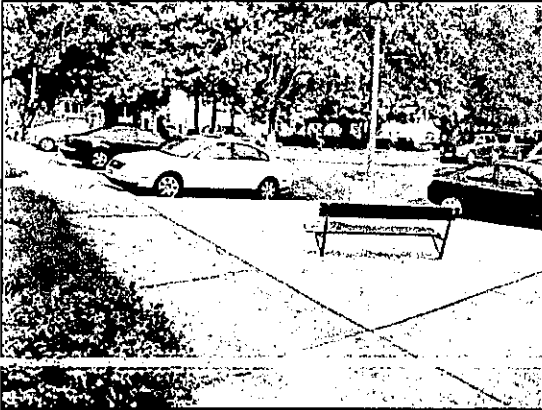
Photo #31. General view of Contessa Court.

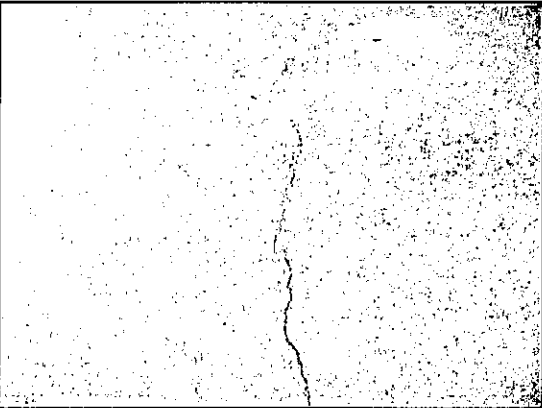
Photo #33. Crack has been sealed at some point but the sealant has failed and the crack has grown, Contessa.

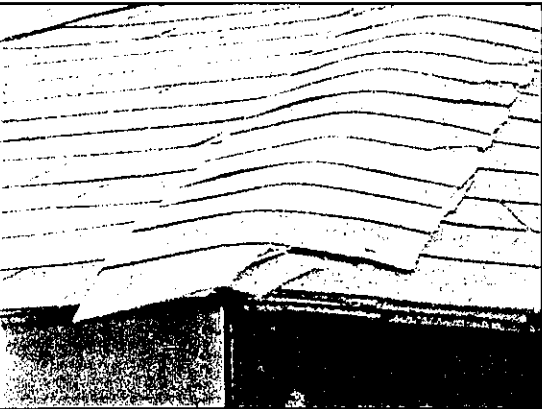
Photo #35. Typical damaged asphalt shingles on the gazebos, Contessa.

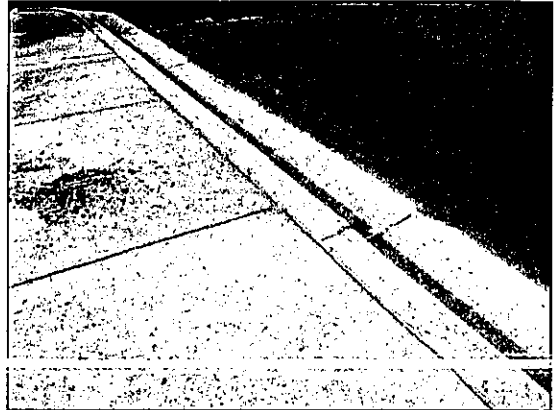
Photo #32. Typical displaced concrete components where a difference in elevation between the components has created a potential trip hazard.

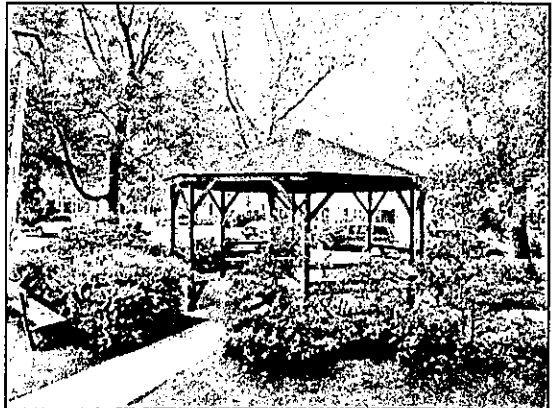
Photo #34. General view of the Contessa Gazebo.

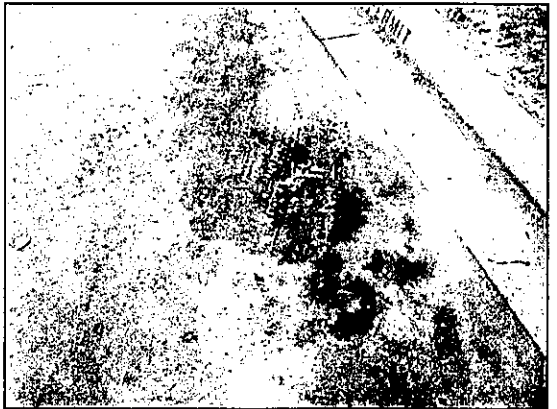
Photo #36. Typical oil/gasoline damaged asphalt pavement.

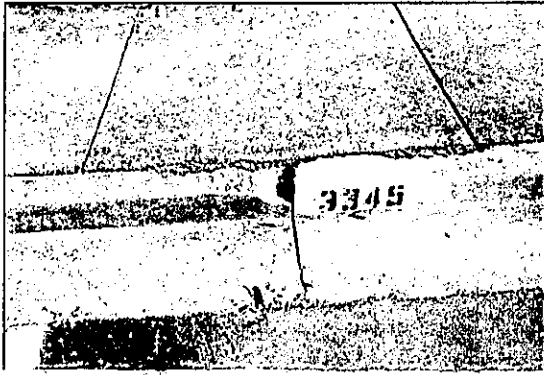
Photo #37. Typical damaged concrete curb & gutter.

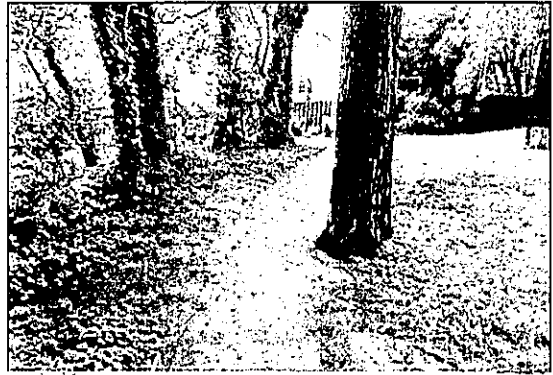
Photo #38. Grade adjacent to the asphalt trail impounds water, silt and debris on the trail.

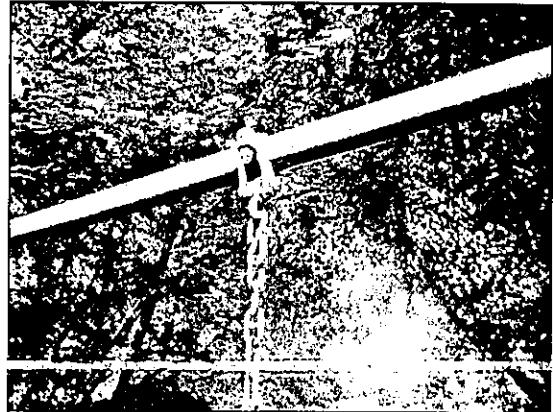
Photo #44. Fasteners are rusting, Whipple Tot Lot

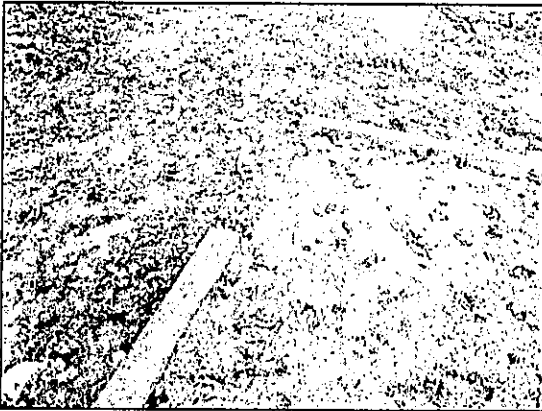
Photo #45. Missing section of wood border, Whipple Tot Lot.

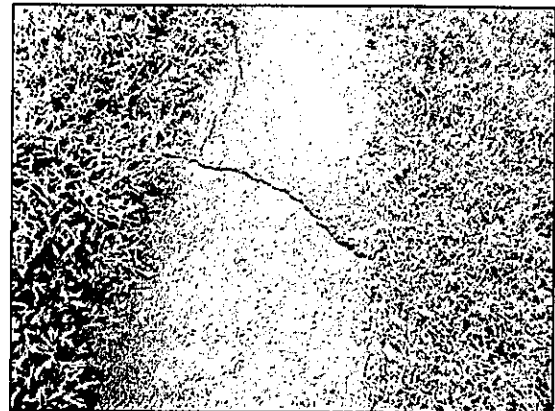
Photo #46. Typical large open crack in the asphalt trail, near the Whipple Tot Lot.

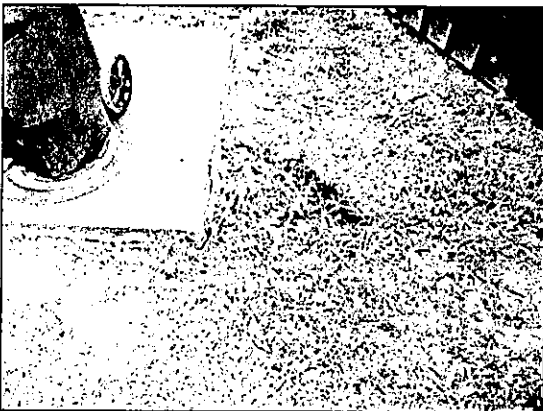
Photo #47. Erosion/sinkhole near the Whipple Tot Lot.

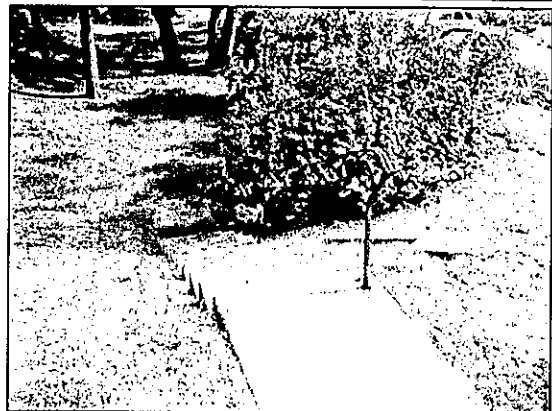
Photo #48. Typical damaged sign, and metal stair railing, Whipple Court.

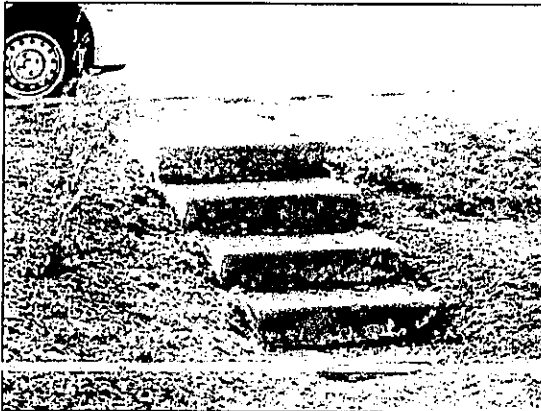
Photo #49. Concrete stair without a proper handrail, Whipple Court.

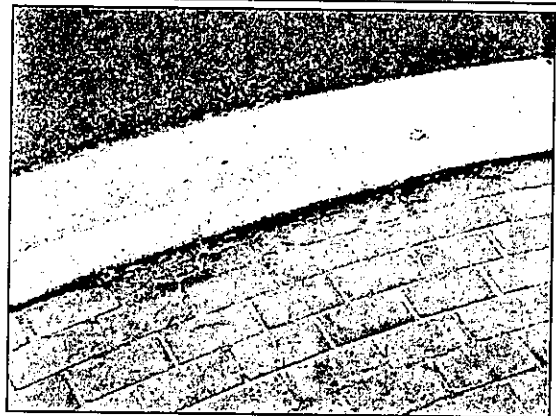
Photo #60. Displaced brick pavers are a potential trip hazard.

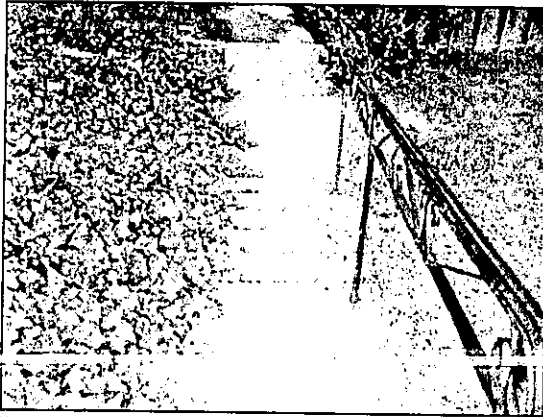
Photo #61. Railing is not properly installed into the concrete steps, Breckenridge Court.

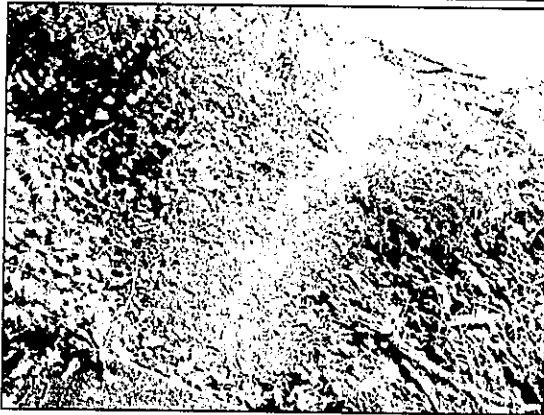
Photo #63. Asphalt trail terminates at an unsafe slope at Tobin Road.

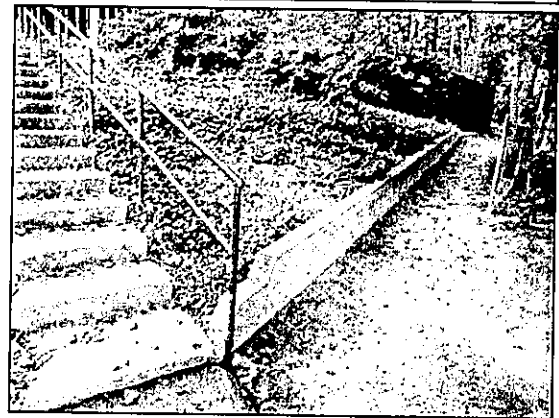
Photo #64. Small wood retaining wall, Breckenridge Court.

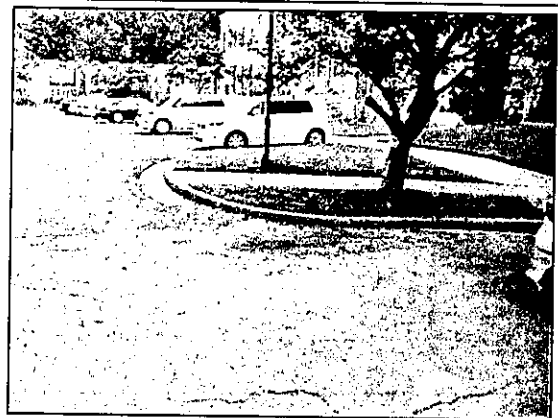
Photo #66. Depressed pavement indicating damage to the base materials and bearing soils, Breckenridge Court.

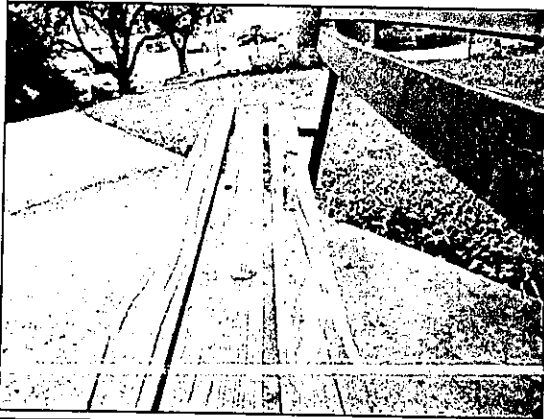
Photo #67. Typical checked wood bench slats and failed paint system.

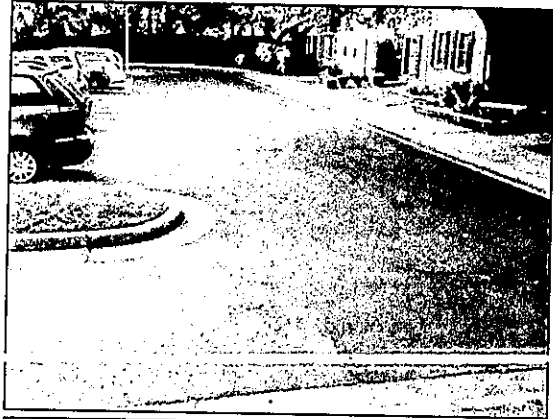
Photo #68. General view of the parking area off of Thompson Road.

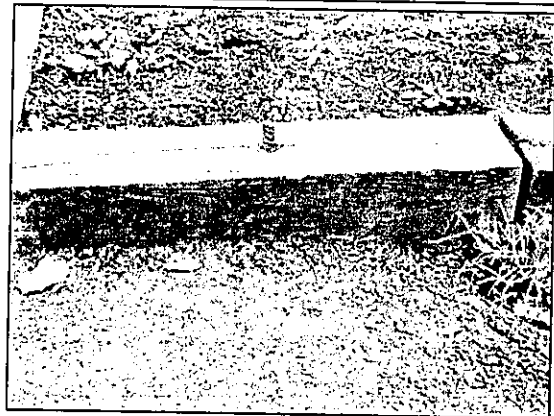
Photo #72. Improperly installed re-bar is a hazard, Conquistador Tot Lot.

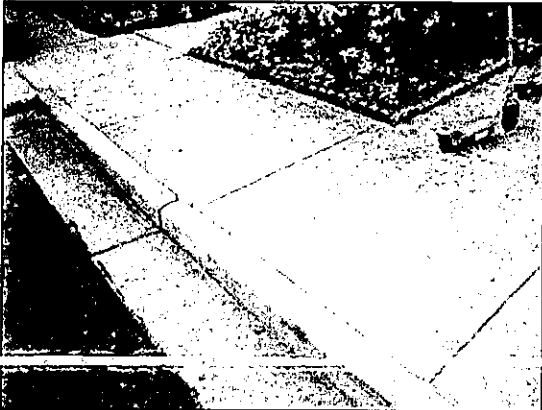
Photo #73. Severely deteriorated concrete pavement, Conquistador.

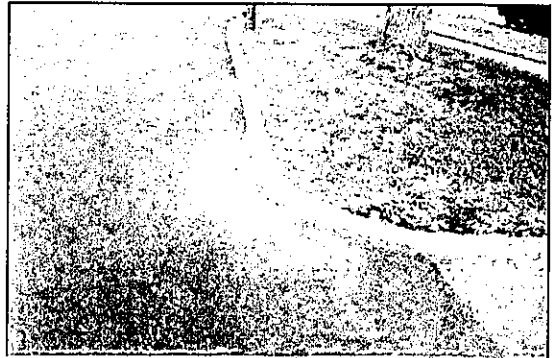
Photo #74. Asphalt pavement is not properly pitched to move water to the storm water system. Correction will require the replacement of the concrete curb.

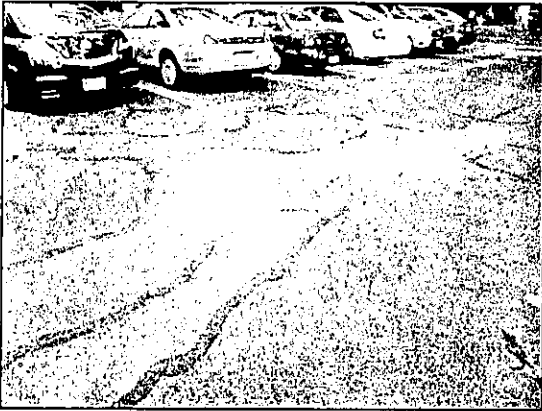
Photo #75. Depressed asphalt pavement indicating damage to the base materials and bearing soils, Conquistador.

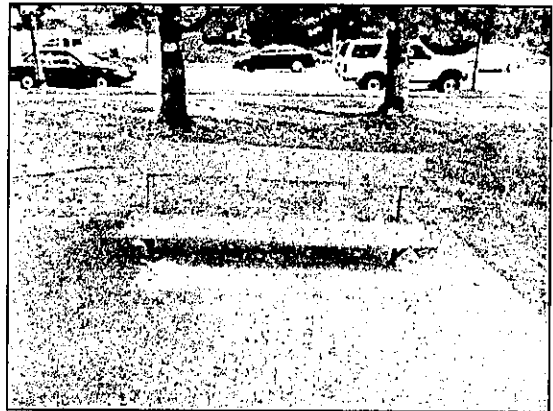
Photo #76. Typical bench.

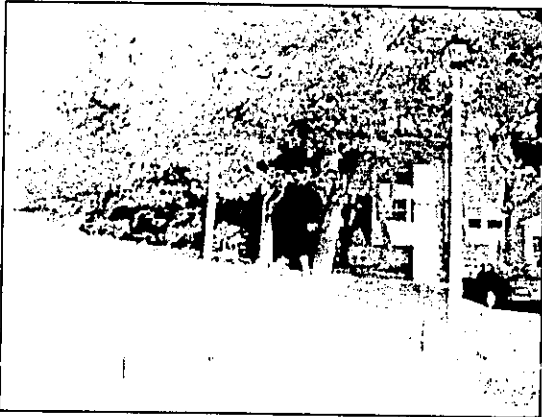
Photo #79. Missing street sign at Viscount Court.

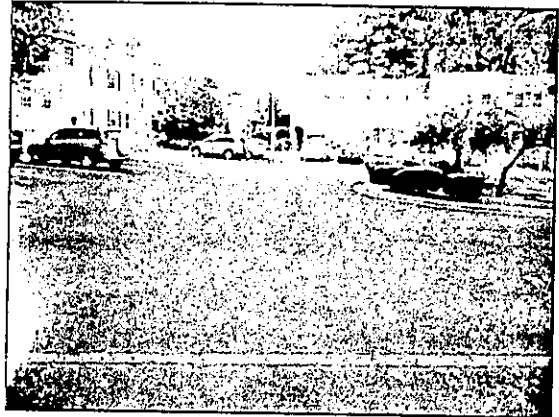
Photo #80. General view of Viscount Court.

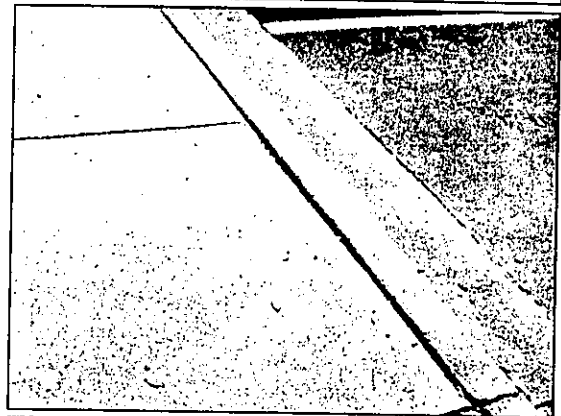
Photo #82. Typical displaced concrete components where a difference in elevation between the components has created a potential trip hazard.

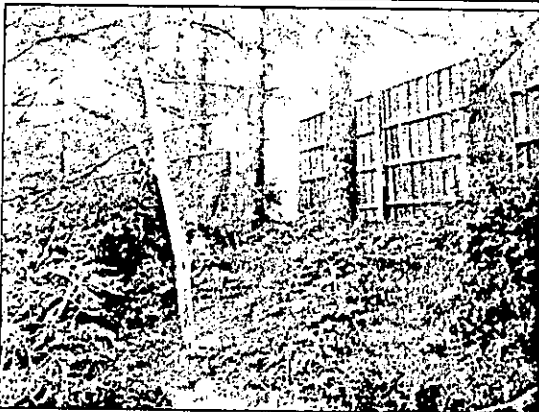
Photo #83. Damaged fence installed along the east property boundary.

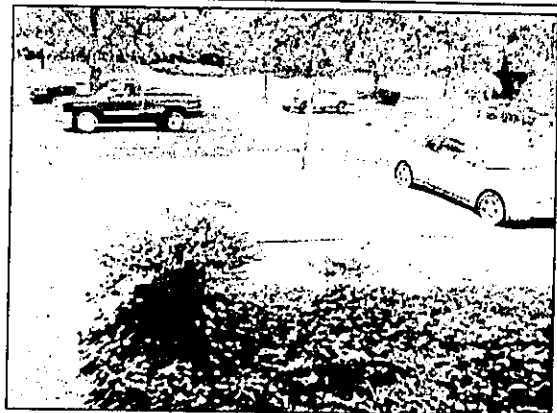
Photo #84. Displaced concrete pavement segments, Viscount.
