STRATHMEADE SQUARE

SECTION III

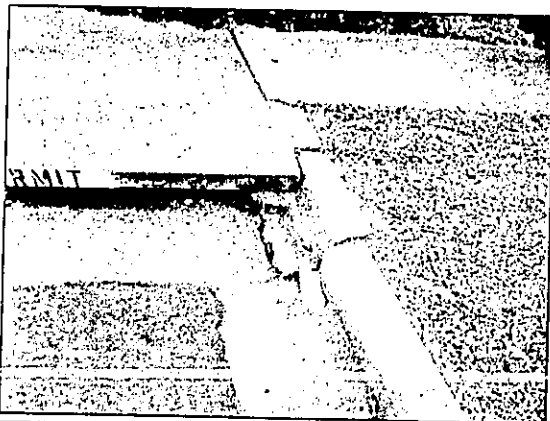
Photo #85. Damaged curb & gutter and storm water inlet apron.

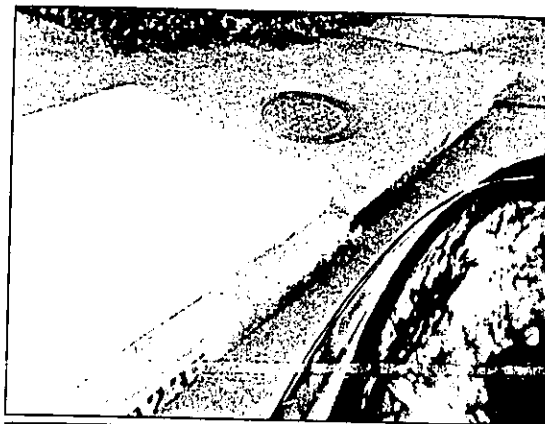
Photo #86. Concrete sidewalk replacement did not correct a potential trip hazard, Viscount.

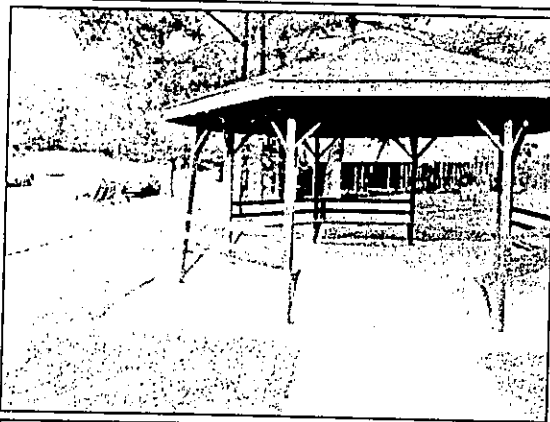
Photo #87. Damaged gazebo, Decourcey.

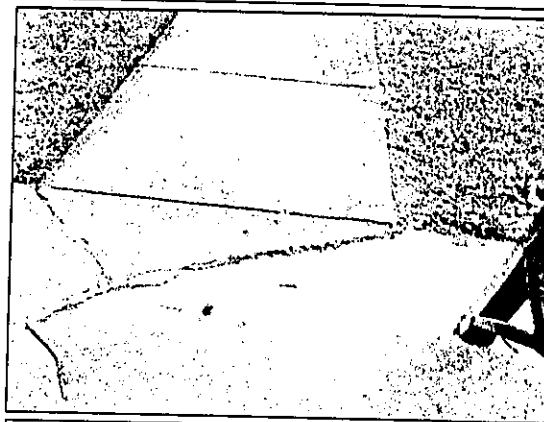
Photo #88. Damaged concrete pavement at the Decourcey gazebo.

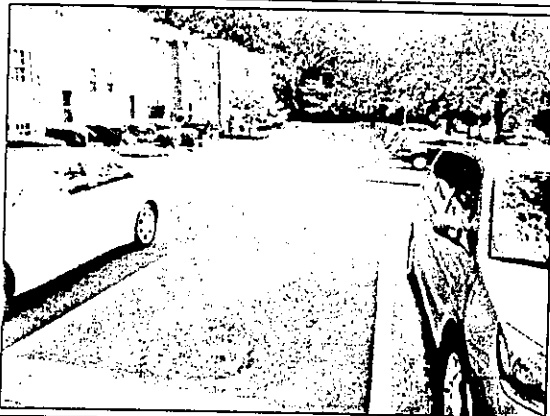
Photo #89. General view of Decourcey. Note gasoline/oil damage to the pavement.

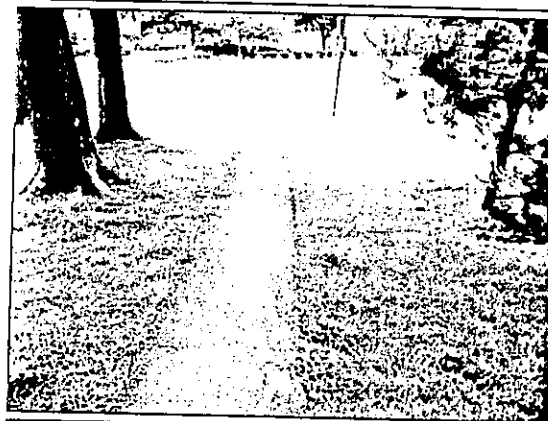
Photo #90. Asphalt trail has extensive cracking and displacement.

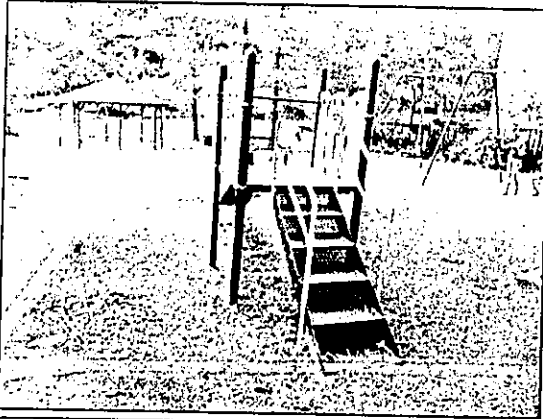
Photo #91. General view of Decourcey Tot Lot.

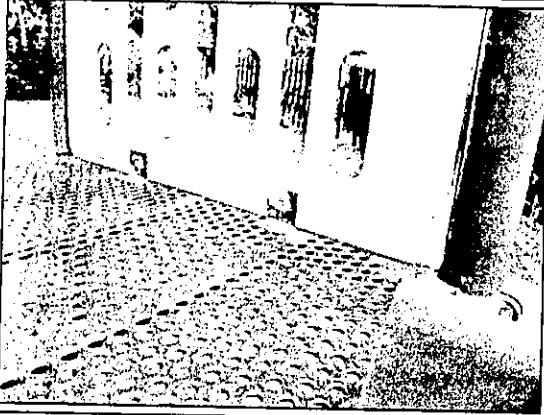
Photo #93. Failed finish on the clips using to assemble the tot lot equipment, Decourcey Tot Lot.

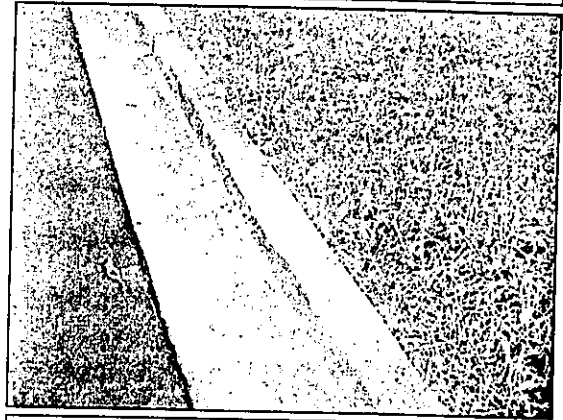
Photo #94. Damaged concrete curb, Decourcey.

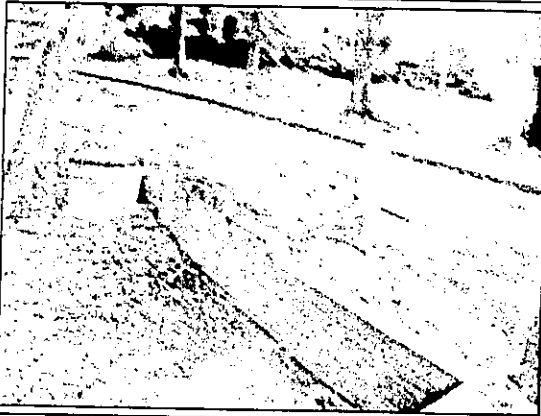
Photo #95. Wood retaining wall at a storm water inlet between Decourcey and Victor.

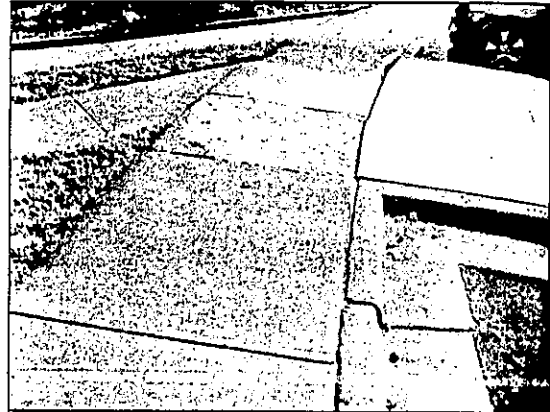
Photo #98. Concrete sidewalk is severely deteriorated and displaced, Victor Circle.

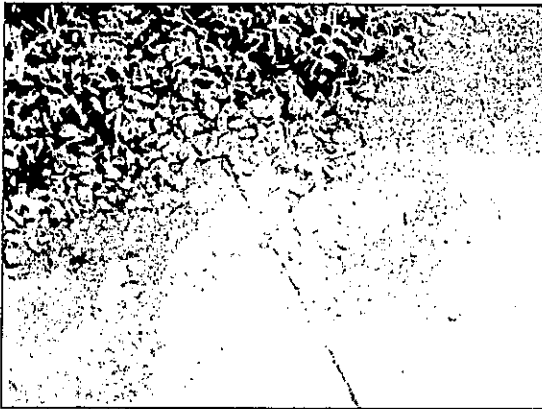
Photo #99. Severely deteriorated concrete pavement, Victor Circle.

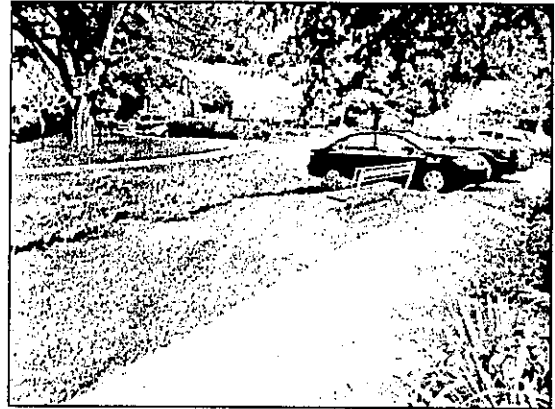
Photo #100. Small section of brick pavers, Victor Circle.

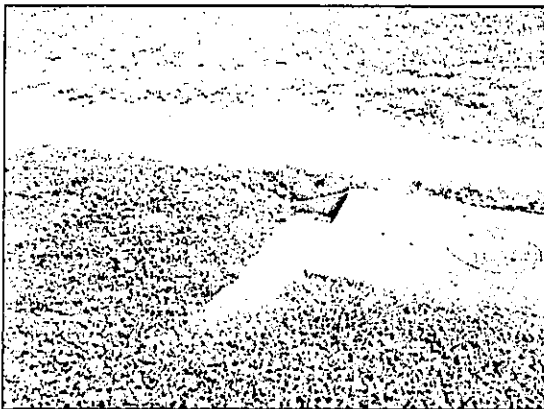
Photo #101. Grade adjacent to the asphalt trail is a potential trip hazard.

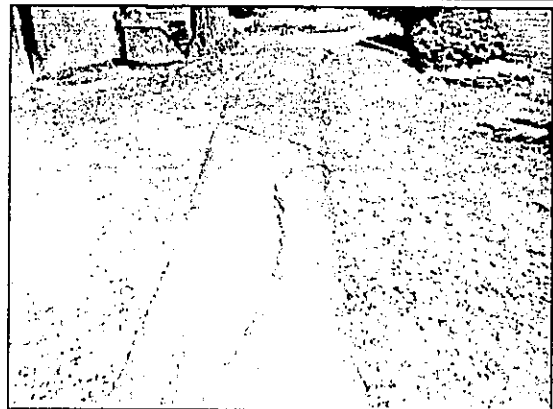
Photo #102. Large open cracks in the asphalt trail, Gastonbury.

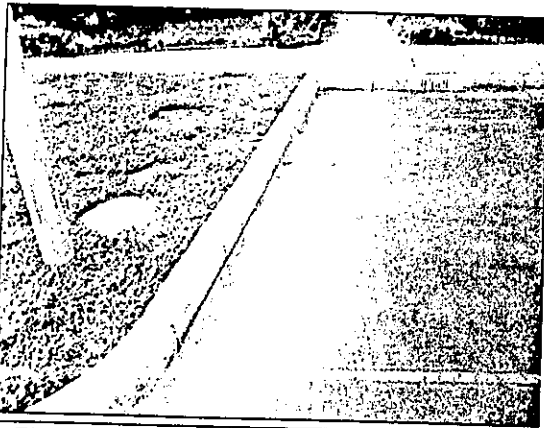
Photo #103. Concrete curb & gutter is not properly pitched to move water to the storm water system, Gastonbury.

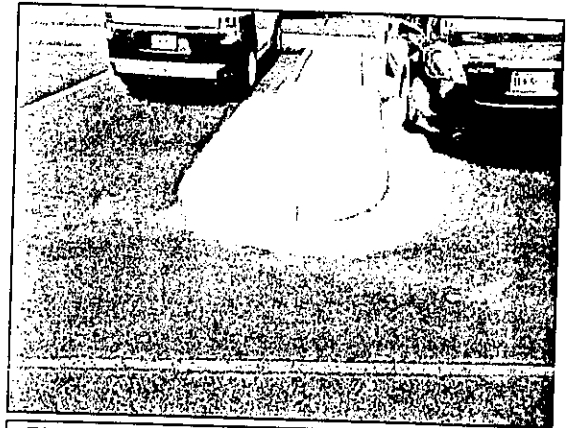
Photo #104. Recently replaced concrete components are already damaged.

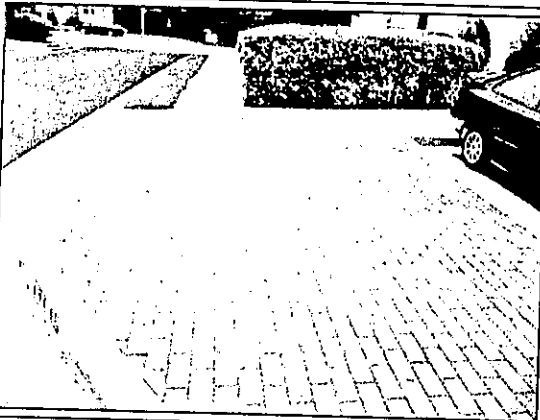
Photo #105. Several areas of brick pavers are installed throughout the community.

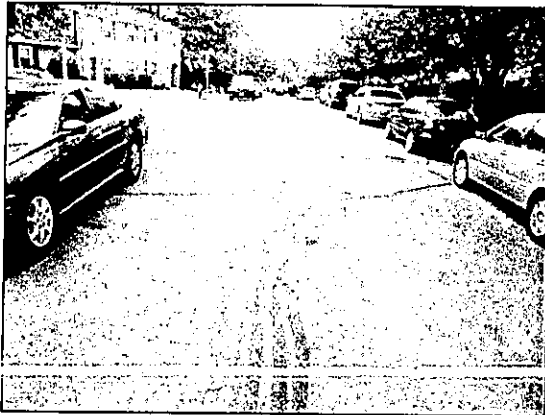
Photo #109. Thompson Road asphalt pavement is generally in poor condition.

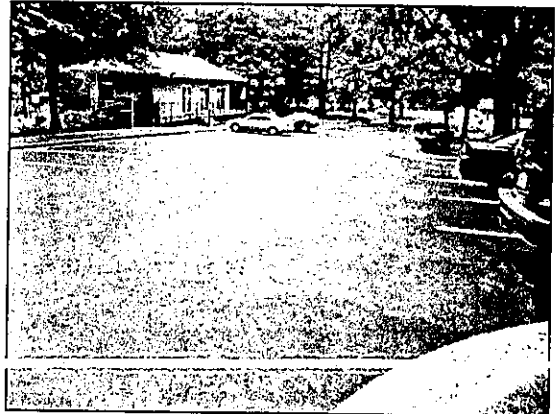
Photo #110. Community Building parking lot.

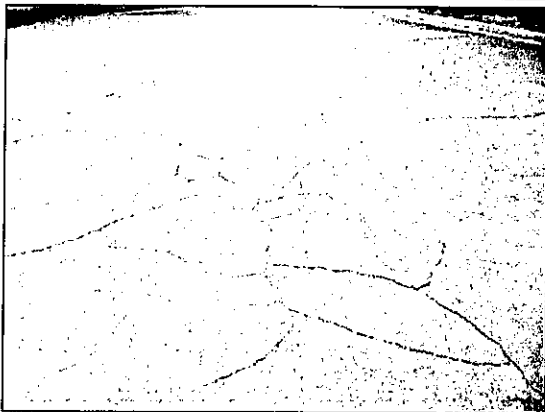
Photo #119. Asphalt pavement is generally in very poor condition, Breckenridge Court.

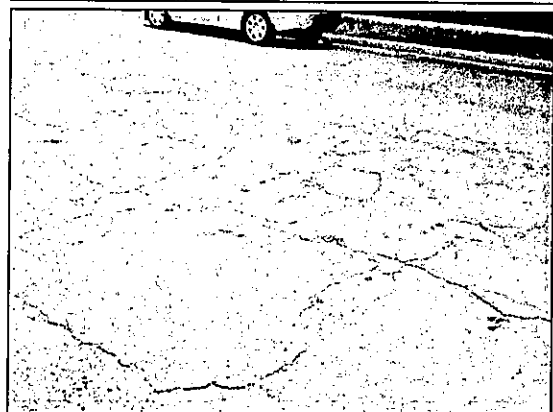
Photo #120. Beverly Drive asphalt pavement is generally in very poor condition.

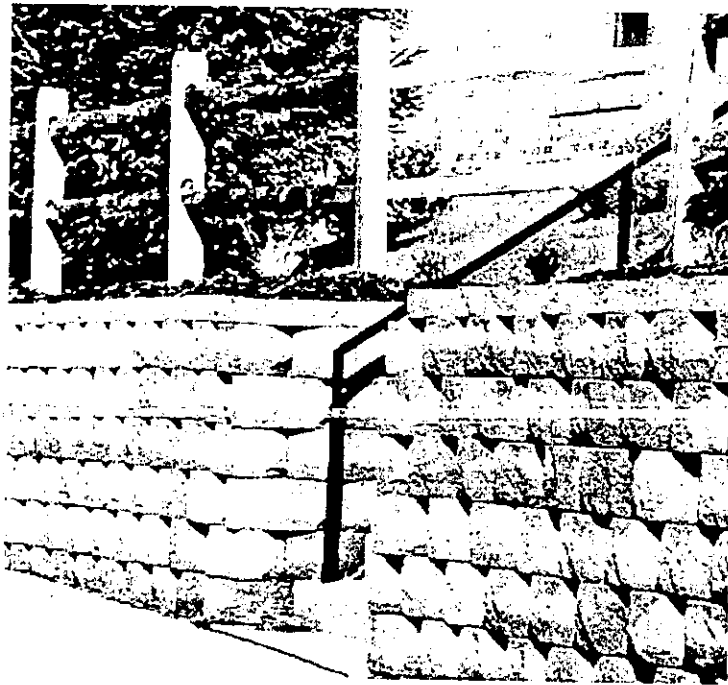
## Battery Heights Condominiums
